Background Information

The City Of Washington Distribution Warehouse Fire

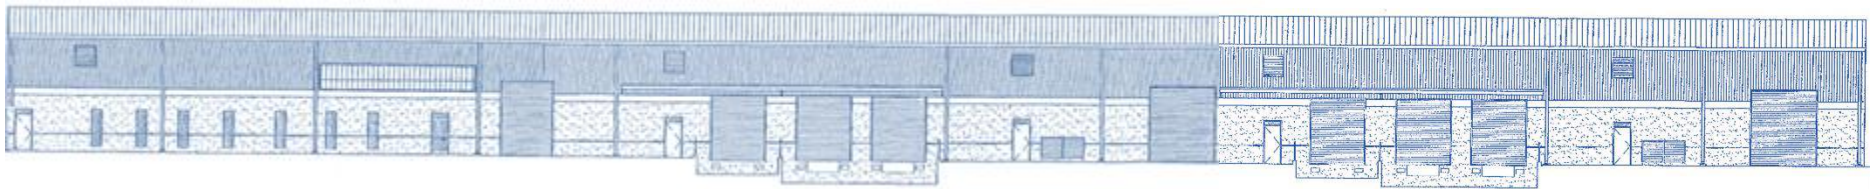
SIDE A

Side A Warehouse
67,000 Square Feet (63,000 Warehouse / Storage)
