Background Information

The City Of Washington Distribution Warehouse Fire

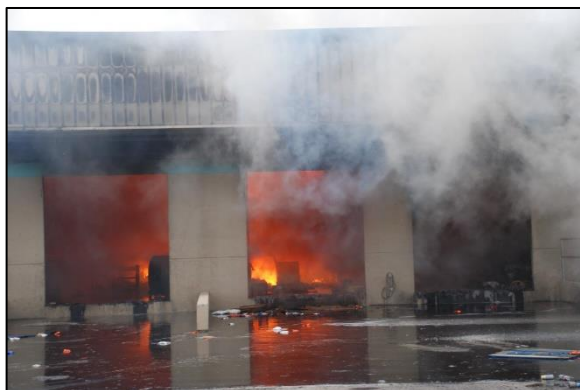
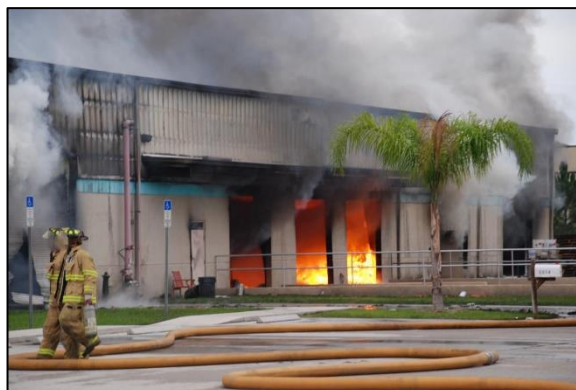
The fire load in most areas of the warehouse was very high, due to the nature of the business and the contents in storage with large amounts of cardboard debris. The warehouse contained coffee, food commodities, house hold chemicals, and cleaning products that typically incorporate large quantities of plastics, such as Mylar, cardboard, and other synthetic materials with coffee products inside. These materials burn quickly, produce large quantities of smoke, and have high thermal energy release rates. Many of the products in the warehouse were easily ignited, which supported rapid fire spread below the reach of the sprinkler heads. In addition, the smoke generated during burning gave a dark optical density that impeded visual acuity.

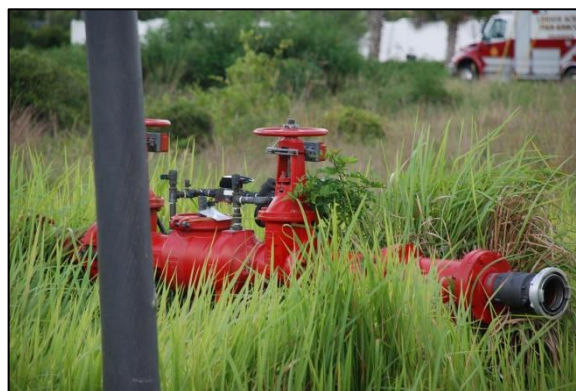
During renovation of the building, a fire pump was required because the water supply system was not able to provide sufficient pressure to meet the design requirements of the additional square footage. Due to the strict time frame of completing renovations and the unavailability of fire pumps required for the system, the contractor substituted a foreign-made fire pump. The fire pump complied with foreign regulations and international codes of practice similar to the National Fire Protection Association (NFPA). In addition, the fire pump met International Organization for Standardization's ISO 9001: 2008 *Quality Management System* standards specifically for centrifugal pumps and jockey pumps used in automatic sprinkler installations. However, the foreign-made fire pump was not Underwriters Laboratories (UL) approved. It is unknown how the fire pump was approved by the authority having jurisdiction.

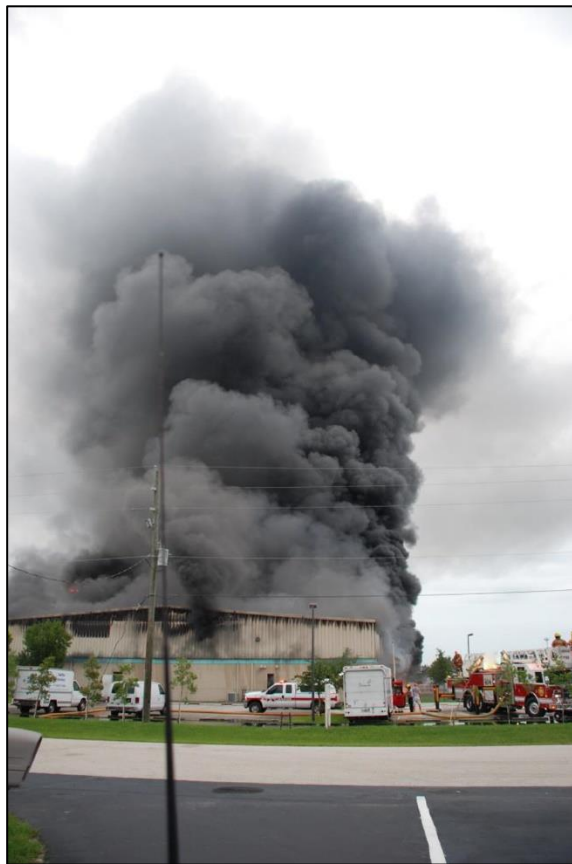
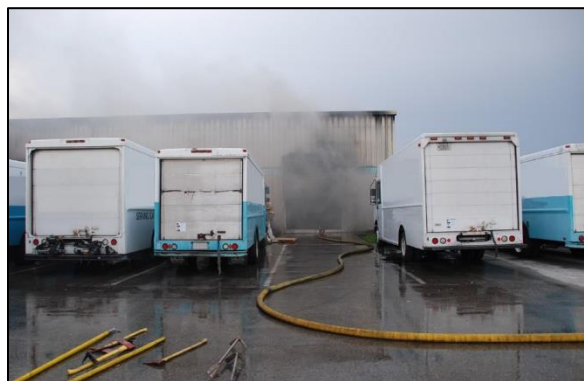
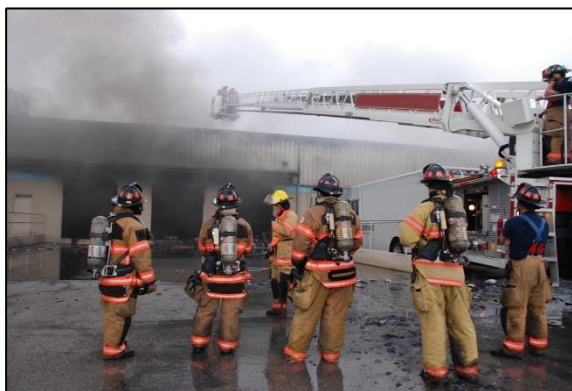
A large amount of cooking oil (56,000 pounds in five-gallon containers [cooking oil weighs between 6-8 pounds per gallon]) made the fire difficult to extinguish. The oil began to run out of the structure making walking and handling equipment even more challenging.
